**2008 Operations, Maintenance,  
and Monitoring Report**

**Black Bayou Hydrologic Restoration**

State Project Number CS-27  
Priority Project List 6

April 2009  
Calcasieu and Cameron Parishes

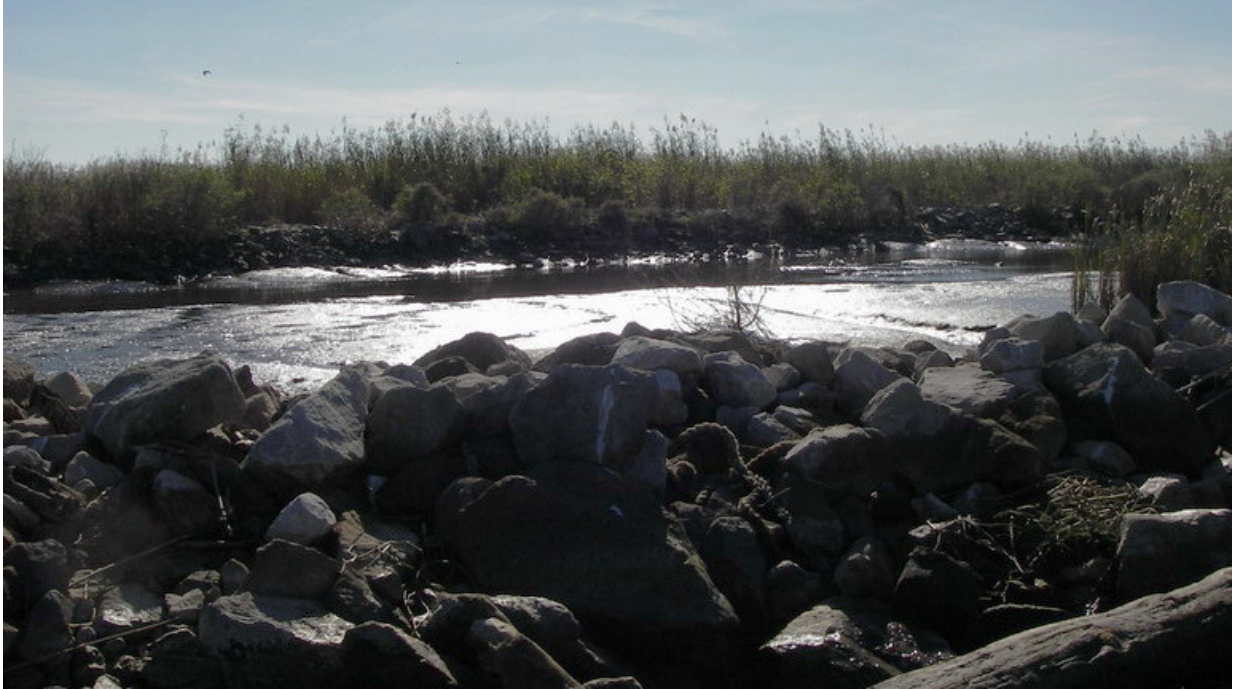
**Figure 11.** Sedimentation and vegetative growth between the GIWW rock dike and dredge material levee along the north side of the impoundment.
